Failure Analysis of Hydraulic Cylinder Bolt on Turntable Vibrating Compactor in Aluminum Processing Plant

Indah Permata Sari ^{a,*}, and Warman Fatra ^{b,*}^{a)} Undergraduate student of Mechanical Engineering Department, Universitas Riau, Indonesia^{b)} Head of Material Testing Laboratory, Mechanical Engineering Department, Universitas Riau, Indonesia

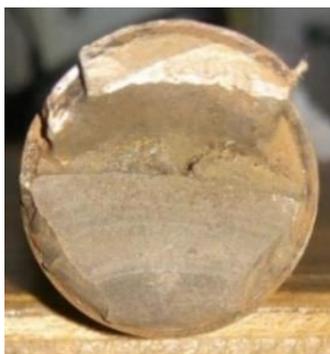
Figure 1: Fracture of failure bolt

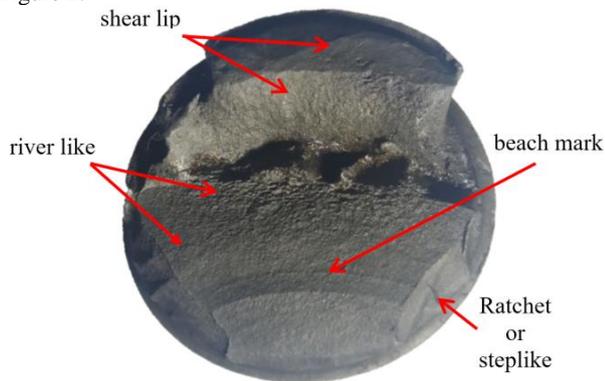
Figure 2: Macro and micro-scale features of failure bolt

In Figure 2 can be seen the failure was initiated by micro-crack in a surface discontinuity region or the bolt thread. The single micro-crack turned into several micro-cracks to form a step like or ratchet. The ratchet was propagated in a flat progressive zone, which contained beach mark. The beach mark proved that the fracture was initiated and propagated by fatigue mechanism. The beach mark was also a sign that the service condition of the bolt had been stopped due to the operation shutdown or changes of the fluctuating load level [9]. Both of ratchet and beach mark were signs of cyclic load.

The river like feature was a sign of brittle fracture [10], which is analogous to as a 'river flow'. A number of small branches in the interior united to form an upstream, then propagated and triggered macro-crack on the exterior. The combination of upstream and micro-cracks at the initiation site caused the crack growth rate increased progressively and overload was occurred continuously. The remaining cross-sectional area was not able to hold this mechanism, so the final fracture was occurred at the shear lip with high nominal stress characteristics.

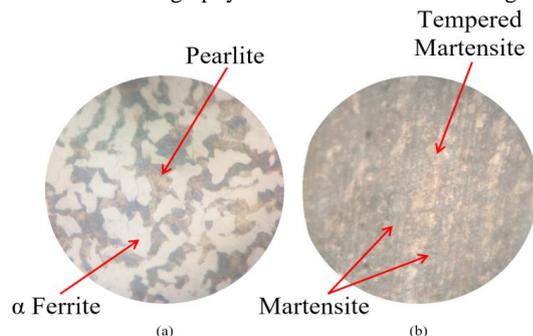
Figure 3: Microstructures of failure bolt (a) transversal and (b) longitudinal tangential section. 100x

From Figure 3a, it was recognized that the formation both of α -ferrite and pearlite in the interior were resulted by slow cooling rate.

According to Callister [1], this due to during the cooling process, specimen was not possible to be cooled in the uniform rate, so that the specimen temperature on the exterior decreased faster than the interior. The martensitic structure of quenching and the tempered martensite structure of tempering as shown in Figure 3b increased endurance limit of the failure bolt exterior because a tempered martensite structure provided the highest fatigue limit. The failure is estimated due to pearlite formation in the interior because the pearlitic structure, particularly those with coarse pearlite, has a poor fatigue resistance [11].

An endurance limit influenced the other fatigue parameters, i.e. fatigue strength and fatigue cycle. Decrease of the endurance limit after pearlite formation due to fatigue strength decreased. The lower of fatigue strength, so the application of load that can be accepted by hydraulic cylinder bolt also be lower. The application of load exceeded the endurance limit, where the fatigue cycle requirement was not reached.

In order to obtain the minimum hardness requirement, the AISI 4140 steel should be heat-treated by using suitable heat treatment, i.e. 850-860°C for 30 minutes and then oil quenched. For tempering process should be 540°C for 2.5-3 hours. As the alternative material for hydraulic cylinder bolt, the AISI 4140 steel can be replaced with AISI 4063 steel because its higher endurance limit, about 600 to 800 MPa.

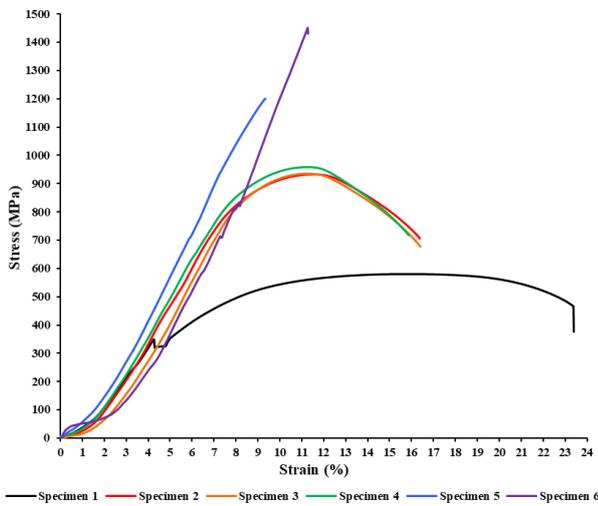
The engineering stress-strain curve of the new specimens are shown in figure 4, with specimens are classified into 3 groups, that is group A consists of specimen 1, group B consists of specimen 2, 3 and 4 and group C consists of specimen 5 and 6. The group A is estimated as non-heat treated, while the group B is estimated as quenched and tempered. The group C are the specimens that being quenched during the study. Although the specimens of the group C got the same treatment, there is a quite different σ_u between both of specimens, so that specimen

6 is estimated as the quenching result of group A, while specimen 5 is estimated as quenching result of group B.

Figure 4: Engineering stress-strain curve of new specimens

The higher heating temperature and the longer holding time of tempering caused the decreasing of the hardness and the ultimate tensile strength, which is the goal of Q + T treatment could not be reached. This caused the decreasing of endurance limit, so the application of load that just a little above the endurance limit will reduce the life cycle of the hydraulic cylinder bolt.

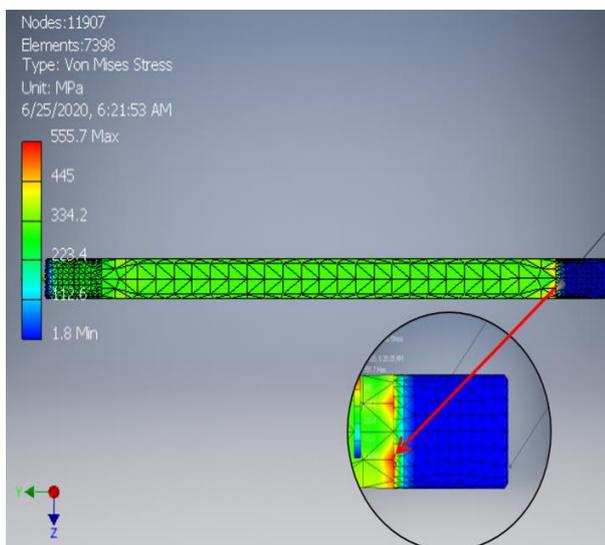
Figure 5: Result of simulation test with service condition

Based on the provisions above, the test result can be seen in Figure 5. From Figure 5, the simulation revealed the maximum stress of 555.7 MPa that was located at the boundary of un-discontinuity surface and the fixed constraint bolt thread. This information indicates an operating stress above 555.7 MPa has tendency of failure initiation at that location. This was confirmed by the failure bolt where the final fracture was occurred at the location as the indicated simulation.

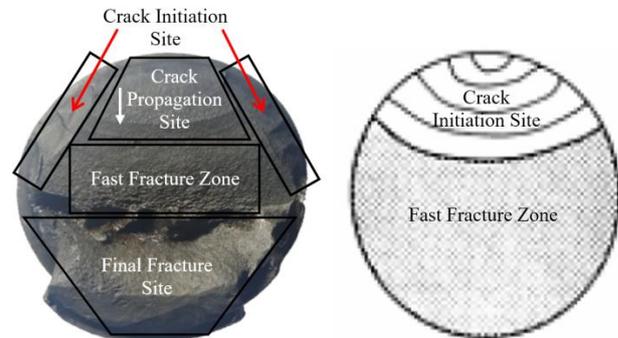
Figure 6: Comparison of failure bolt fracture to schematic of fatigue fracture according to ASM Handbook Volume 12

According to several tests that have been conducted, failure of hydraulic cylinder bolt is estimated as a low cycle fatigue failure. In order to confirm this estimation, the comparison in Figure 6 can be used.

According to Figure 6, the crack initiation sites show the failure of the hydraulic cylinder bolt was occurred with no stress concentration. The fast fracture zone about 2/3 of the total failed cross-sectional area shows the fatigue zone, which contains macro- and microscale features is small. Both of those indications confirm the hypothesis of the hydraulic cylinder bolt failure mode due to the Low Cycle Fatigue (LCF) failure after high nominal stress application.
