# SEM Observation on Fracture Surface of Coconut Fibers Reinforced Polyester Composite

Muhtil Badri<sup>a</sup>, Sugiman<sup>a</sup>, Aguswandi<sup>a</sup>, Jayadi<sup>a,\*</sup>

<sup>a</sup>) Department of Mechanical Engineering, Universitas Riau, Indonesia

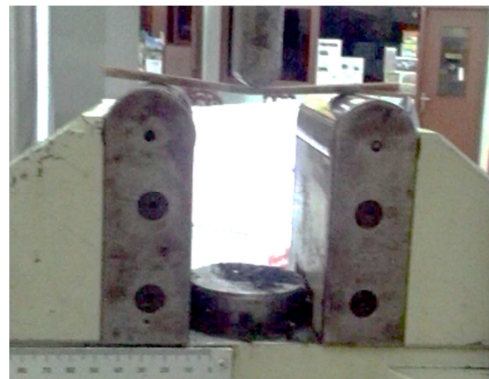
**Figure 2:** Flexural testing machine

The three points bending flexural test of composite sample is carried out in ASTM D 790 test standard. In flexural test, a uniaxial load was applied through both the end as shown in Figure 2.

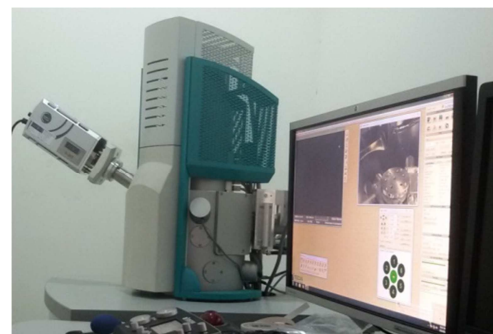
**Figure 3:** TESCAN VEGA3

The morphological characterization of the composite surface is observed in scanning electron microscope of TESCAN VEGA3 as shown in Figure 3. TESCAN offers the LaB6 – lanthanum hexaboride – electron source as an option, which can be classified as somewhere in-between the Schottky emitter and a tungsten heated filament.
