Fracture Surface of OPEFB Fiber Reinforced Polymer Composites-Polymeric Foam Sandwich Panels under Static Loading Conditions

Muftil Badri,^{a,*} Dodi Sofyan Arief,^a Erik Sitio Johannes,^a Ridho Zarli Rahmat^a

^aDepartment of Mechanical Engineering, Universitas Riau, Indonesia

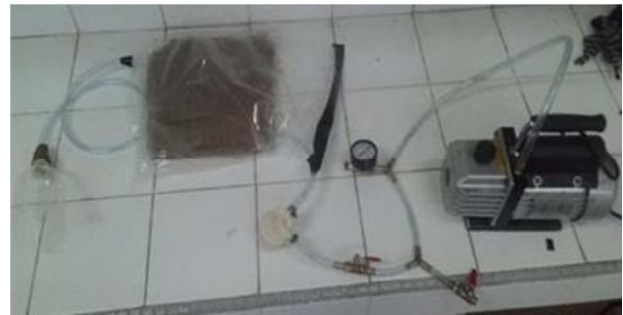
The working procedure of the composite technique of making VARI method (Fig. 1) is by operating the pump, after the vacuum pump is operated then adjusting the pressure by closing the inlet channel then arranging the control valve opening to adjust the pressure. The pointer on the manometer is noted until it shows the number of pressure scales to be used.

Figure 1: Vacuum assisted resin infusion (VARI)

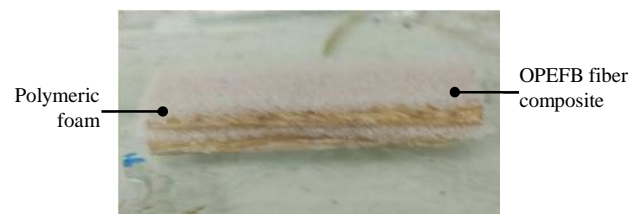
Figure 2 shows OPEFB fiber reinforced polymer composites-polymeric foam sandwich panels. This composite material has been made on a highly compact layered structure. The maximum layer thickness of 0.5 mm. The resulting layers are macroscopically bonded together into a composite material.

Figure 2: OPEFB fiber reinforced polymer composites-polymeric foam sandwich panels

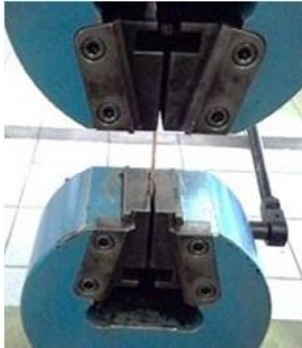
The standard used is ASTM D638- 03 the gauge length and

cross head speeds are chosen according to the standard.

Figure 3: Tensile testing machine

The test is carried out in Universal Testing Machine (UTM) at room temperature as shown in Figure 3. The test involves application of tension in the work piece until it fracture. The tensile stress recorded according to strain. The test conducted for the following combinations and corresponding graph is plotted.

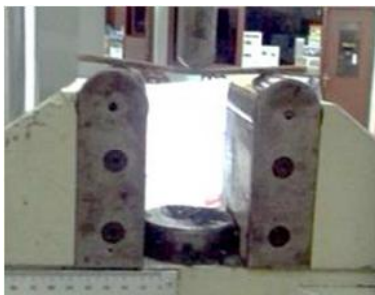
The three points bending flexural test of composite sample is carried out in ASTM D 790 test standard. In flexural test, a uniaxial load was applied through both the end as shown in Figure 4.

Figure 4: Flexural testing machine

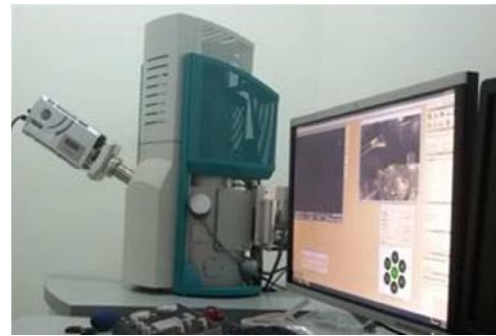
The morphological characterization of the composite surface is observed in scanning electron microscope of TESCAN VEGA3 as shown in Figure 5. TESCAN offers the LaB6 – lanthanum hexaboride – electron source as an option, which can be classified as somewhere in-between the Schottky emitter and a tungsten heated filament.

Figure 5: TESCAN VEGA3

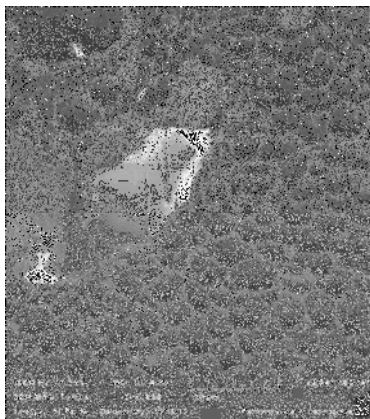
Figure 11 shows the micrograph of OPEFB fibers/matrix pullout were treated with mode 3 subjected to uniaxial tensile loading. The nature of fracture surface appearance of OPEFB fibers can also be related to OPEFB fiber composite strength, fiber fracture resistance and fiber degradation and surface defects. OPEFB fibers show individual fiber pullout with little polymer matrix between the OPEFB fibers. The OPEFB fiber boiled with 5% NaOH solution for 30 minutes with temperature 50° C to 80° C reinforced polymer matrix shows a solid bundle which has fractured and pulled-out with intact polymer matrix binding the OPEFB fibers.

Figure 11: SEM of OPEFB fibers pullout were treated with mode 3 subjected to uniaxial tensile loading
