In-Place, Seismic and Fatigue Analysis of Offshore Platform for Life Extension

This paper presents reassessment of existing offshore platform in the Ardjuna Field, Northwest of Java, Indonesia. The existing platform of B1C was installed in 1975 and owned by PHE ONWJ. The B1C platform is numerically evaluated for service life extension purposes until the next twenty years. The reassessment analyses focus on in-place analysis, seismic analysis and fatigue analysis. These analyses refer to recommended practice issued by American Petroleum Institute standard. The results indicated that the entire value of unity check for all members fulfill the requirements of API RP 2A - WSD. Analysis of fatigue computation showed that three joints have the fatigue life less than 59 years.

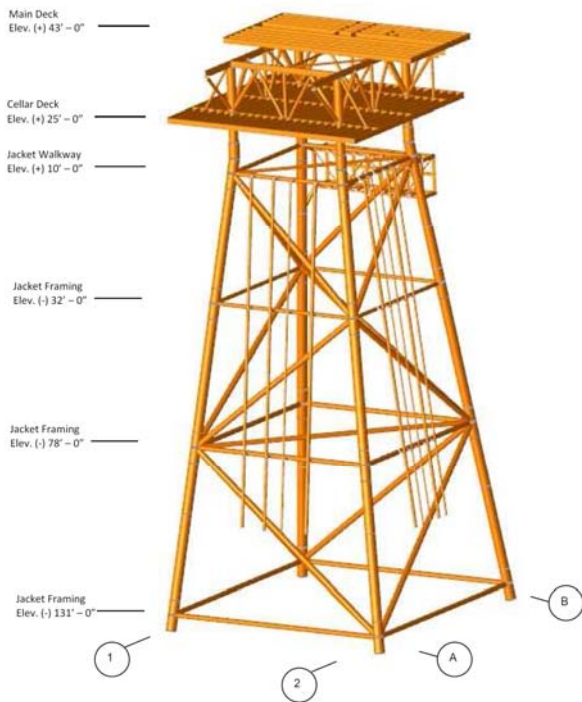
Figure 1: B1C Platform model

The B1C Platform consist of two level deck structures with Main Deck with top of steel elevation at (+) 43 ft, and Cellar Deck with top of steel elevation at (+) 25 ft. The B1C platform considered in the study is a four legged production platform as shown in Figure 1. Water depth at the location is 131 ft below MSL as shown in Table 1. The platform is designed based on the API recommended criteria for 100-years return period for a wave height of 27.3 ft [6]. The environmental data required to determine the loads to this study is presented in Table 1-5, respectively.

The Jacket Leg structure is 40" diameter (with batter 1:8). All Piles are 36" diameter and penetrated to 165 ft below mud line. For axial pile capacity is recommended to use 2870.0 kips for B1C Platform based on report study by Soilmaklelan (1993). For eartquake source information, Dames dan Moore (2000) reported that the estimation of peak ground acceleration (PGA) for Ductility Level Eartquake (DLE) condition is 2.39 m/s².

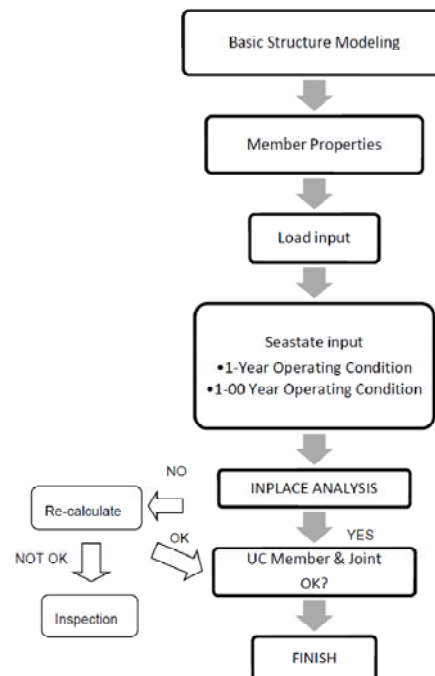
Figure 2: In-place analysis methodology

Static analysis performed by considering loading conditions for Still Water Case, 1-Year Condition and 100-Year Condition. Still Water condition cases combines maximum load operation without taking into account the environmental load, while operational conditions using extreme environmental loads with return period 1 year, and for extreme conditions using extreme environmental loads with return period of 100 years. Design and strength of structures are expressed in Unity Checks (UC) as the ratio between the actual stress that occurs on the member of structure with allowable stress. The UC criteria for each member in the structure should be less than 1.0. The flowchart for in-place analysis can be seen in Figure 2.

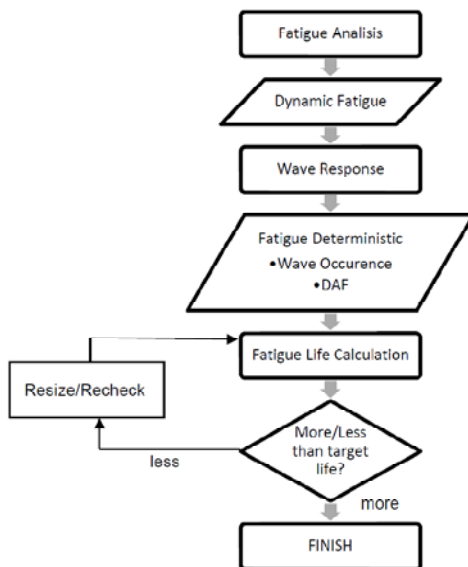
Figure 4: Fatigue analysis methodology

In this study, the B1C platform is analyzed for the design service life for next 20 years. Originally, the B1C platform was designed to have service life for 40 years or until 2015. Based on API RP2A, the value of the safety factor 2.0 is used for the next 20 year service life. So, the entire joint in the structure should have fatigue life more than 59 years. Detail of procedure for fatigue analysis in this study can be seen in Figure 4.

Fatigue analysis is performed to determine the structural response to continual wave loading. Wave induced dynamic force is one of the most significant force leading to fatigue of offshore member structures. Numerical fatigue assessment method is based on S-N curve approach for API standard utilizing spectral method. The calculation of cumulative fatigue damage is based on Palmgren-Miner's rule, which can be written as:

Where, D is the cumulative fatigue damage, n_i is number of stress cycles of a particular stress range, N_i is average number of loading cycles to failure under constant amplitude loading at that stress range according to the relevant S-N curve, and J is number of considered stress range intervals. Failure is predicted to occurs when the cumulative damage (D) over J exceeds a critical value equal to unity.
